Manhole Inspection Summary

Manhole # S15C__004MH

Insp Date: **9/15/09 2:10 PM**

Location Address: **2525 FRANKLIN ST**

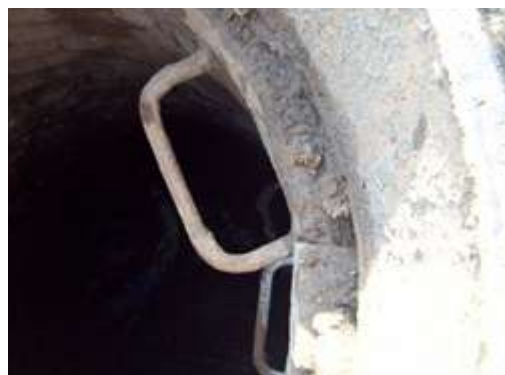
Defect 2

Offset: **1** (in.)

Condition: ☐ Sound ☐ Cracked ☒ **Leaks**

1" FRAME OFF SET

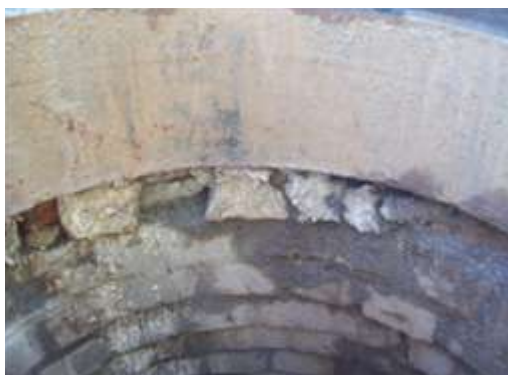
Defect 1

Infiltration: ☐ None ☐ Joint ☐ Cracks ☐ Mortar ☐ Roots ☒ **Wall**

LOOSE AND MISSING BRICKS AT CORBEL, INFILTRATION AT WALL

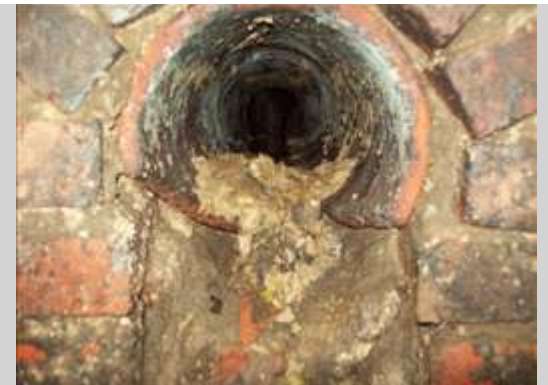
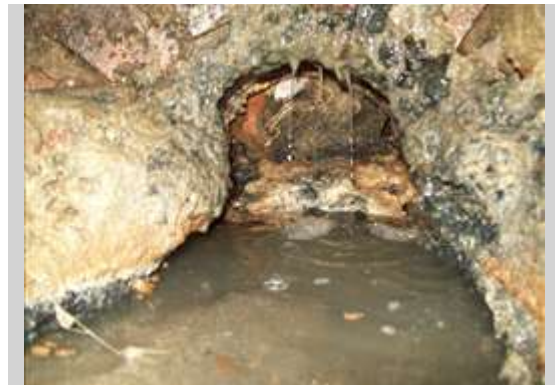
Drop In @ 3 O'Clock

Drop: **Inside** **Direct**
Angled: Reading: (ft.)
Inv Depth: **10.08** (ft.)
Drop Condition: **Partly Clogged**
